**WHEN BAD THINGS HAPPEN TO GOOD [BUILDINGS]**

**Dylan Freytag, Keith Kesner, Randall W. Poston, and Kenneth Bondy**

Synopsis:

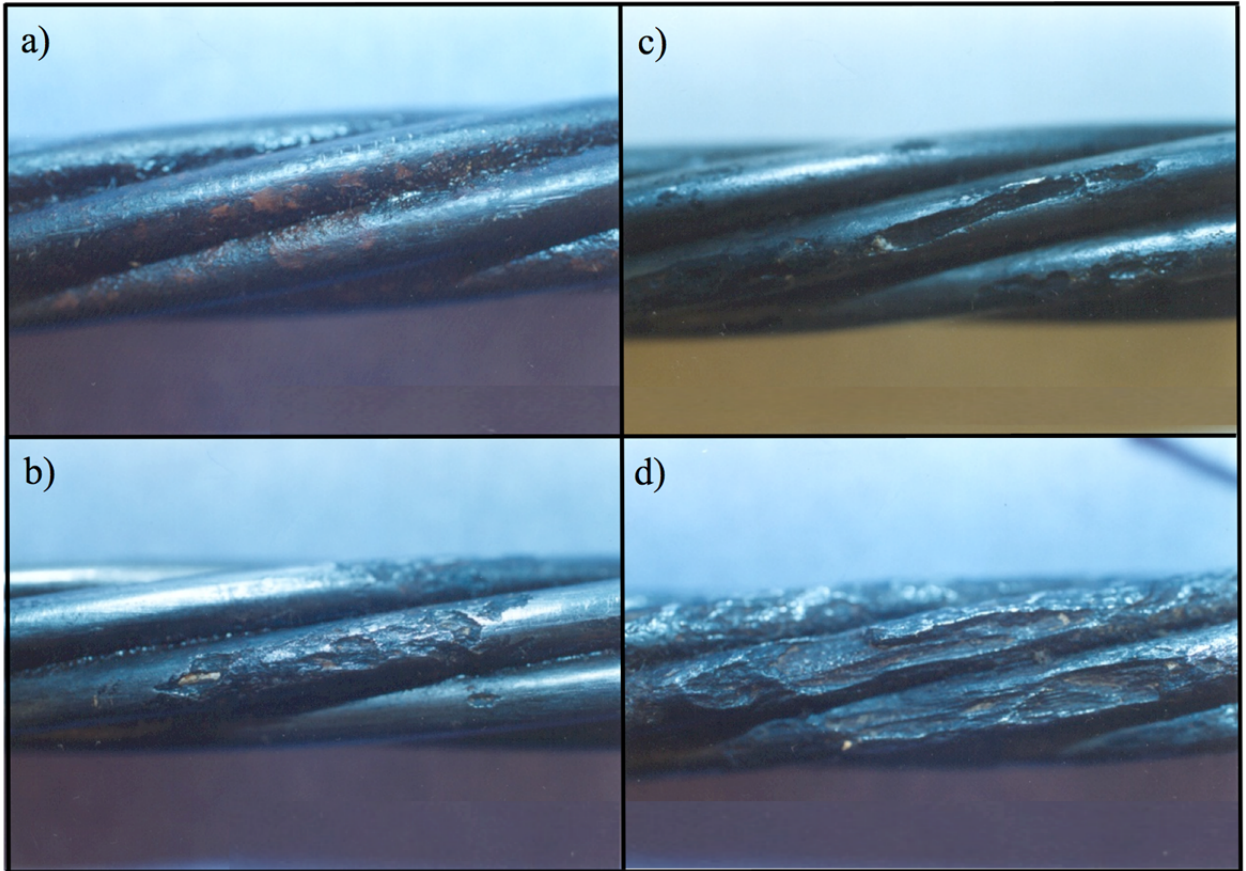
The severity of pits that can form and the approximate strength loss associated with each is summarized in Figure 2. As can be seen, even though pits develop on the surface of the prestressing strand of an unbonded tendon, there is residual strength as measured by mechanical tension testing of the strand. Even in the most severe case (deepest pits, Figure 2d), the residual strength can be as high as 75 percent of the guaranteed ultimate tensile strength (GUTS).

Figure 2— Relative corrosion pitting assessment (adapted from Reference 4): a) surface corrosion, no strength loss; b) mild pitting: no strength loss; c) intermediate pitting: approximately 10% strength loss; d) severe pitting: approximately 25% strength loss.

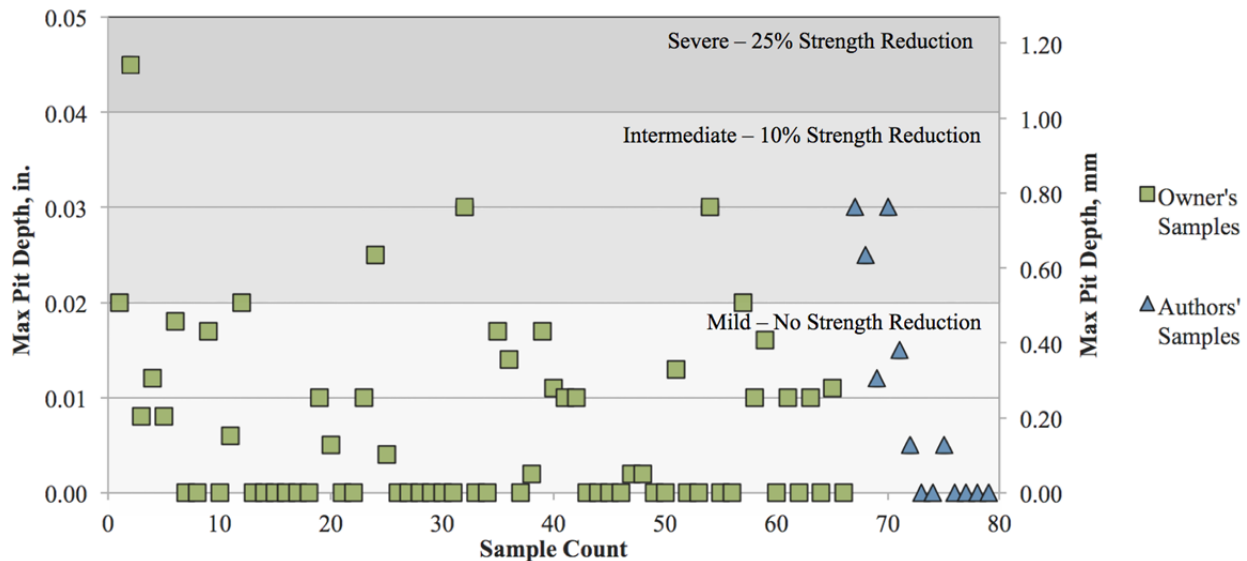
Both the building owner’s consultant team and the authors’ team removed post-tensioning tendons from the subject building for inspection and evaluation pursuant to an agreed investigation protocol. The other team removed portions of about 80 tendons (“live end” anchorages and several feet of strand) and the authors removed fifteen. Figure 3 below summarizes the extent of pitting corrosion that the authors measured on the tendons removed by both parties. The authors measured pits on tendons removed by both parties using ASTM G 46 – Standard Guide for Examination and Evaluation of Pitting Corrosion<sup>4</sup>. The International Concrete Repair Institute (ICRI) classifies the severity of pits for in-service post-tensioning tendons (ICRI 03736<sup>5</sup>), such as those at the subject building. The various levels of pitting have been overlaid in shades below. Note that only one tendon fell within the “severe” (darkest shade) category and was subject to the greatest strength reduction of approximately 25 percent.

Figure 3—Measured pit depths for tendon samples removed from subject building; all measurements performed by the authors.

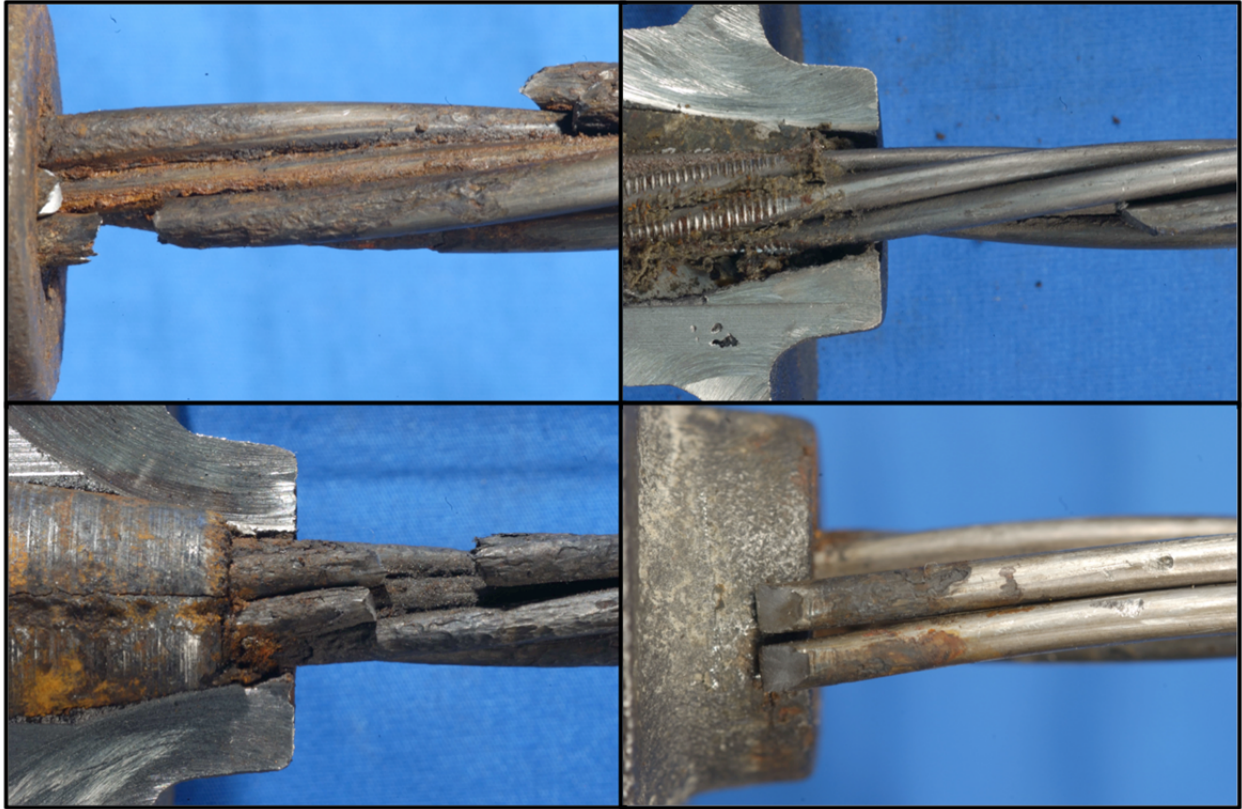
Selected photographs of specimens after testing are shown in Figure 4. In each of these photographs, wire fractures adjacent to the anchors and wedges can be seen.

The ACI 318 Building Code limits stresses at nominal flexural strength in unbonded tendons to a maximum of  $f_{se} + 30,000$  psi. For the subject building, the value of  $f_{se}$  was specified by the design engineer to be 175 ksi (1205 MPa); therefore, the maximum stress at nominal strength in the tendons per the ACI Code is 205 ksi (1415 MPa). The minimum tested value of assembly strength was 230 ksi (1585 MPa, Specimen N18-0.6). Thus, with the *maximum* permissible tendon stress at factored loads per ACI 318 and the *minimum* measured strength from testing, there remains a margin against rupture of at least 25 ksi (170 MPa, 9 percent GUTS). This maximum stress value represents the maximum permissible stresses under factored loads of 1.2DL (dead load) and 1.6 LL (live load) and 1.0 Secondary Moments. Under service load level, the tendon stress is significantly less than 205 ksi (1415 MPa). The evaluation clearly indicated that there was significant reserve capacity compared to code-required strength.

Figure 4—Selected photographs of fractures.

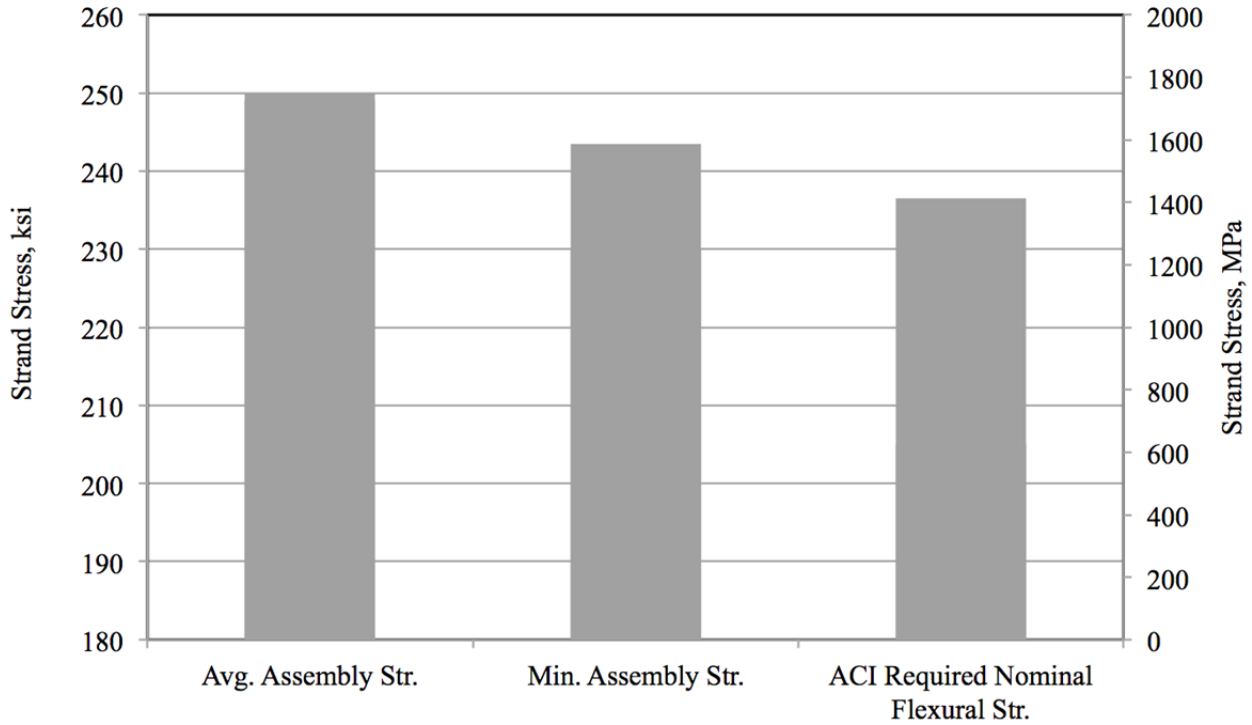
This reserve capacity is evident in Figure 5. The plot depicts the average and minimum assembly strengths as tested by the authors and contrasts them to the code-level required strength. Note that the required nominal strength of the tendon assembly (205 ksi/1415 MPa) is significantly less than the average measured strength (250 ksi/1725 MPa) and the minimum measured strength (230 ksi/1585 MPa). Based on these values, a substantial amount of reserve capacity remained, and the safety of the structure had clearly not been compromised to date.

Figure 5—Required and measured tendon assembly strengths.

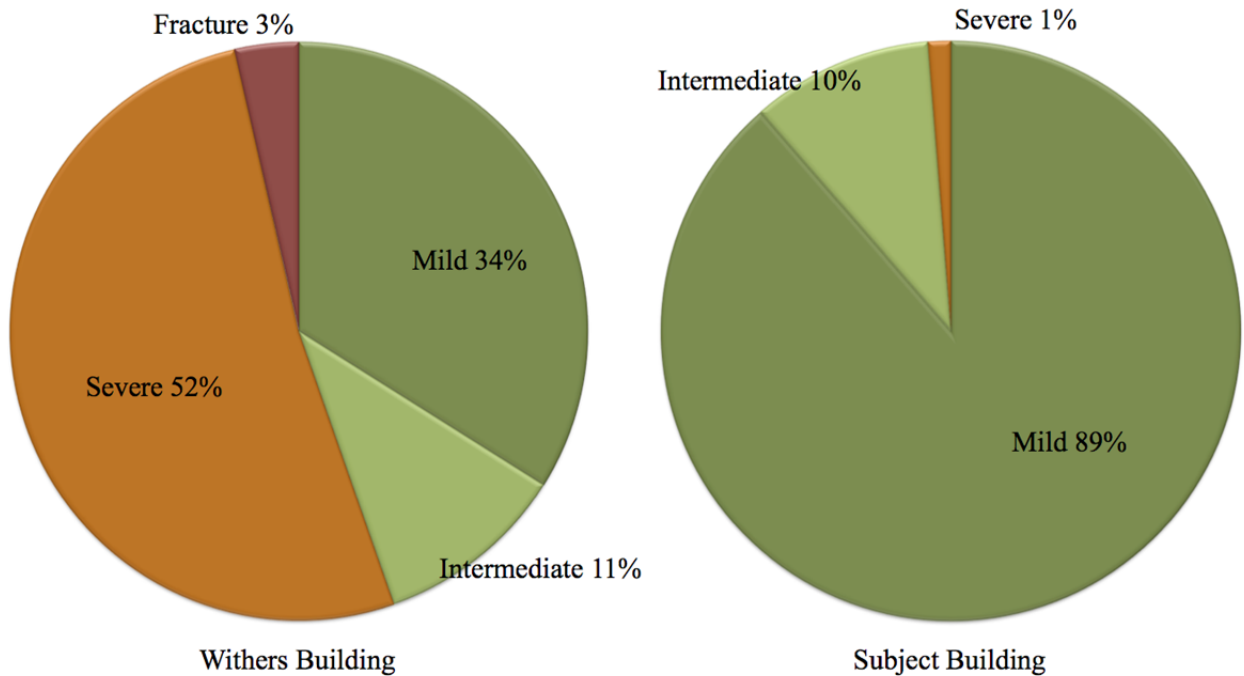
To further illustrate the magnitude of the alleged deficiencies in the subject building, it is possible to draw comparisons with past projects. A dramatic comparison can be made between this structure and the Withers Building that was investigated and successfully repaired by the authors. The Withers Building had severe corrosion present at the time repairs were implemented. Since the completion of repairs the structure remains in-service. The building has been continually monitored since it was repaired more than 13 years ago. Recall that there have been 13 individual wire failures to date, (there are seven wires to a strand) but thus far the University of Virginia has elected not even to replace the tendons associated with those wire breaks. The repair and monitoring program has been so successful that the owner plans to abandon the monitoring system in the near future. Figure 6 compares the observed tendon corrosion on these two structures. Tendon corrosion categorizations for these charts are the same as those used in Figure 2 and Figure 3. Clearly, the Withers Building had a far more advanced state of tendon/anchorage corrosion than was present in subject building. Despite the advanced state of corrosion, the Withers Building was successfully repaired and remains in service; therefore no reason exists to believe that the subject building could not have been easily repaired.

Figure 6—Comparison of corrosion in Withers Building and Subject Building.

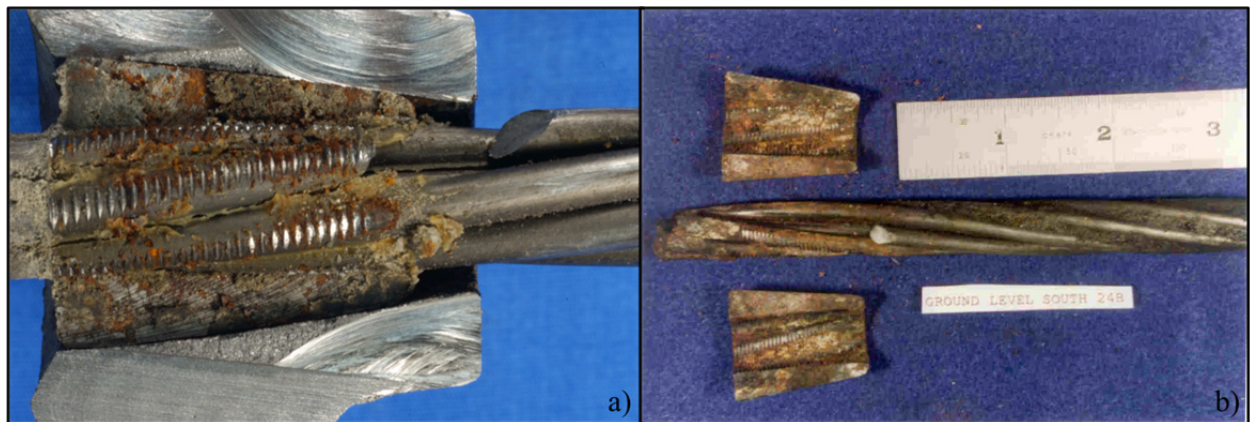
In Figure 7, two photographs of tendons and wedges are shown. On the left is a sample removed from the “subject” building and on the right is a sample removed from the second Florida Condominium building. These two photographs were taken after the specimens were tested to failure. Both exhibited the same type of failure: shear fracture of a single wire. However, the sample from the subject building is less corroded and had a greater tensile strength (258 ksi/1780 MPa) than the Second Florida Condominium Building sample (238 ksi/1640MPa). This building was successfully repaired more than 16 years ago and remains in service.

Figure 7—Wedge assemblies from a) Subject Building sample and b) Second Florida Building sample.
