Use of Shrinkage-Compensating Concrete in Post-Tensioned Buildings

Part Two: A Four-Building Survey
By Kenneth B. Bondy, S.E., FACI

John Wayne Airport Parking Structures A2 and B2, Santa Ana, CA

Ridgecrest Community Residence, University Of Alabama, Tuscaloosa

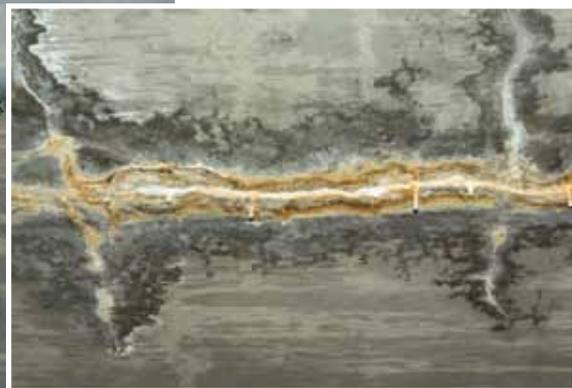
Figure 1: Efflorescence at crack on L1 slab soffit.

were measured and repaired in the 480,000 square feet of floor area in both structures. Prior to repair, some of the cracks allowed the passage of water through the slab, resulting in unsightly efflorescence at the slab soffit and potential damage to cars below (Figure 1).

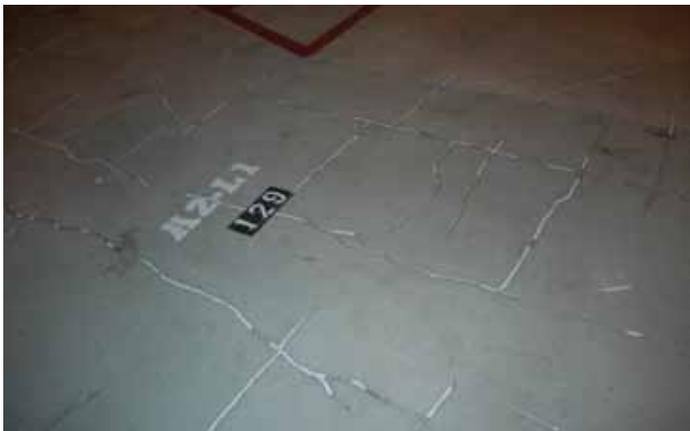
Figure 2: Typical repaired cracks on structure A2 Level L1.

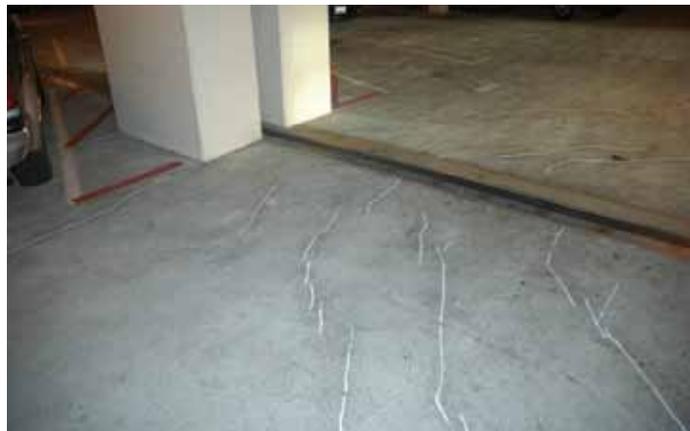
Figure 3: Top of slab near expansion joint, structure A2 Level L1.

Figure 3 (page 27) shows the top of the slab at a double column straddling the expansion joint at the L1 level. Diagonal cracks radiate off the columns in an orientation consistent with RTS on either side of the expansion joint. Figure 4 shows the top of the slab on the L2 level, exactly one floor above the location shown in Figure 3. The slab is crack free at this location.

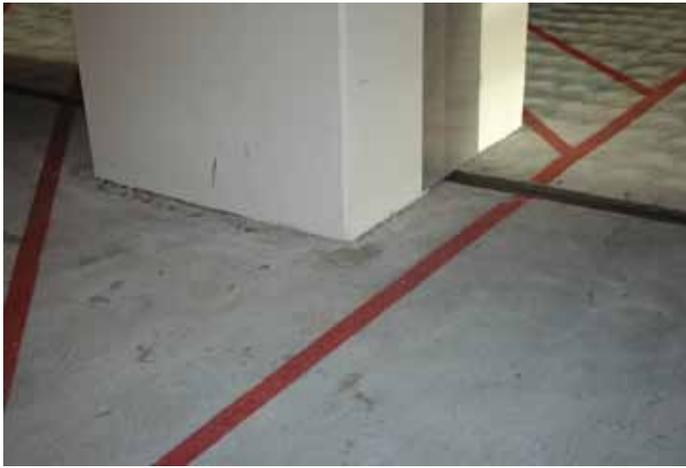
Figure 4: Same Location as Figure 3, One Floor Up On Level L2.

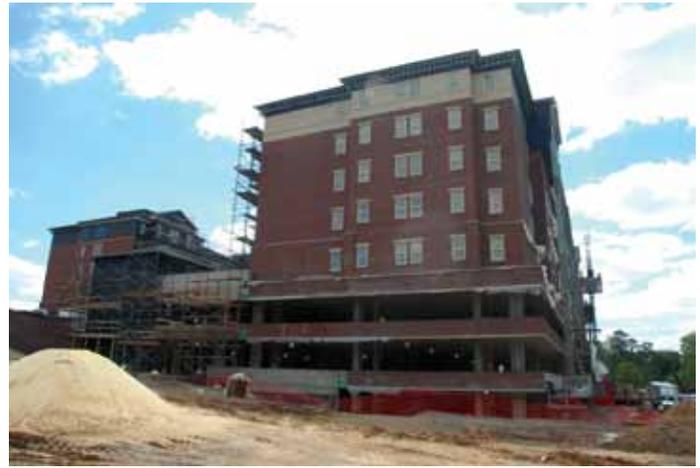
The photograph in Figure 5 was taken in April, 2009 when the building was structurally complete but architectural finish work was still underway.

Figure 5: North elevation showing three lower parking levels and five upper residential levels.

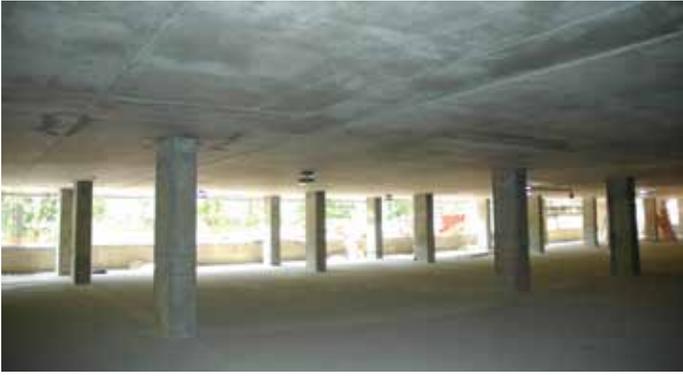
Soffit of First Level slab (standing on slab-on-ground) looking northwest. The first supported level is the most susceptible to RTS cracking.

Construction started in 2007 and the building was completed in 2009. During an onsite inspection of the parking level slabs in April 2009, they were found to be in excellent condition. No cracking was evident related to RTS or applied load. Careful observation of the far corners of each of the sections separated by the expansion joint – where the most RTS cracking could be expected – revealed these critical areas to be crack-free. An experienced observer of post-tensioned slabs would rate the performance and condition of these large slabs as outstanding.

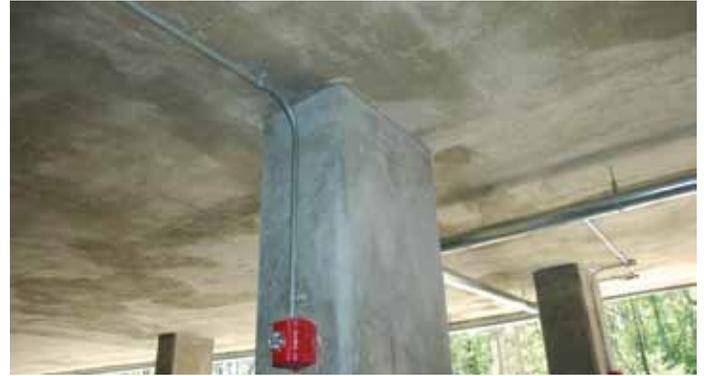
Slab-column joint at First Level near northwest corner of slab.
